Inspection Report

Minerals Regulatory Program

Mine Name: Brown's Canyon Rock Quarry	Permit Number: M/043/0021
Operator Name: BMW Stone Inc.	Inspection Date: 05/20/2009
Inspector(s): Brett Gregory for Leslie Heppler <u>BGH</u>	Time: 1:00 pm
Other Participants: None	Mine Status: Active

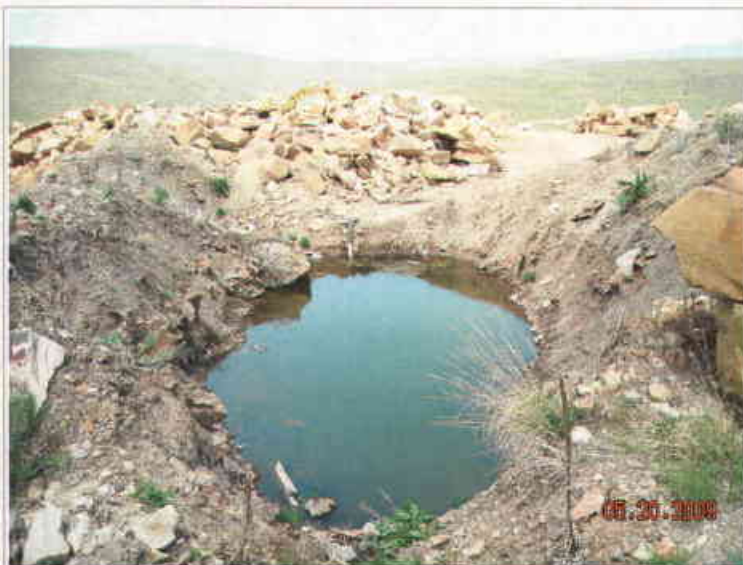
Pit to be backfilled.

- 2) A few minor pieces of garbage along the perimeter need to be picked up. There are also considerable amounts of garbage in the parking lot area that should to be removed. Old machinery or equipment, as seen in the photographs, will affect the bond amount and are to be removed.
- 3) The entire perimeter around the overburden was saturated with water and may pose a drainage problem. There is also a pit shown in the photographs to be backfilled and checked for contamination.

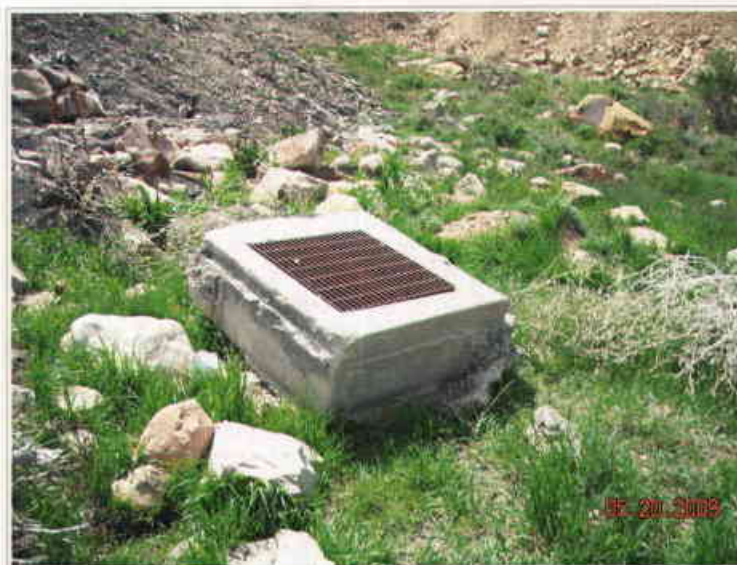
Garbage to be removed.

Conclusions and Recommendations: DOGM recommends to remove garbage and stockpile more topsoil for future reclamation. Bond will be escalated in December 2009, Operator should consider concurrent reclamation to decrease percent of bond increase. DOGM will continue to annually inspect this site.

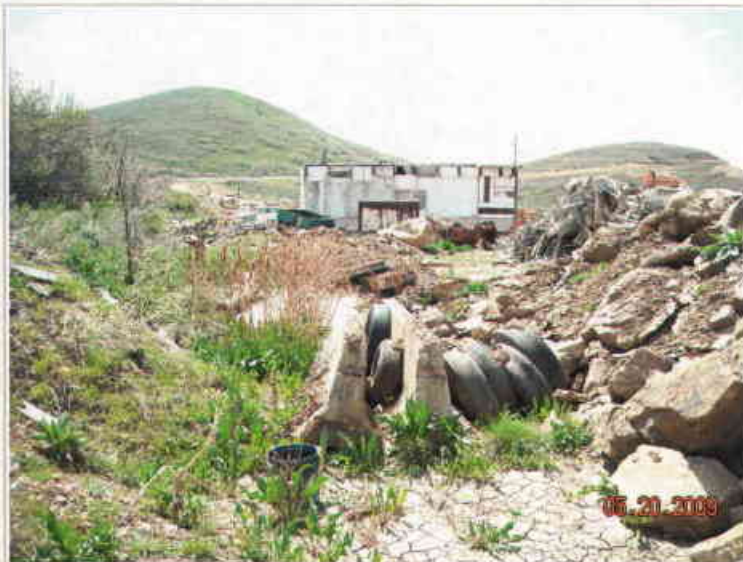
Structures & garbage that will affect the bond amount

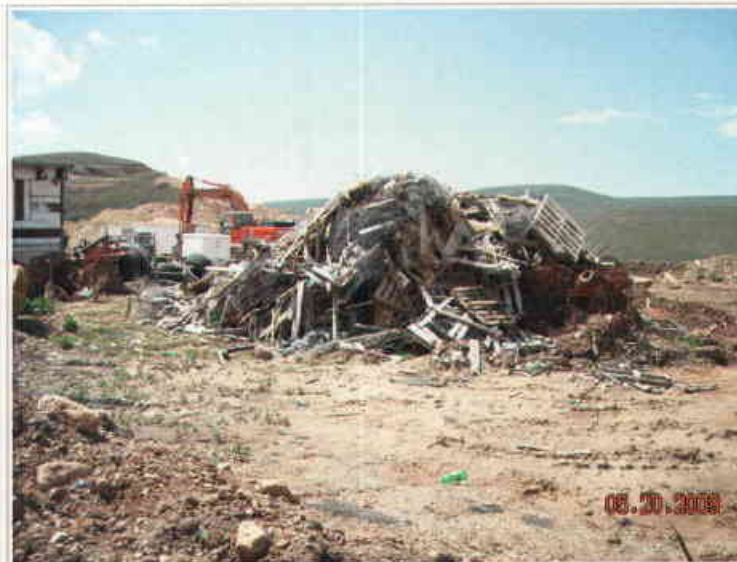
Garbage.

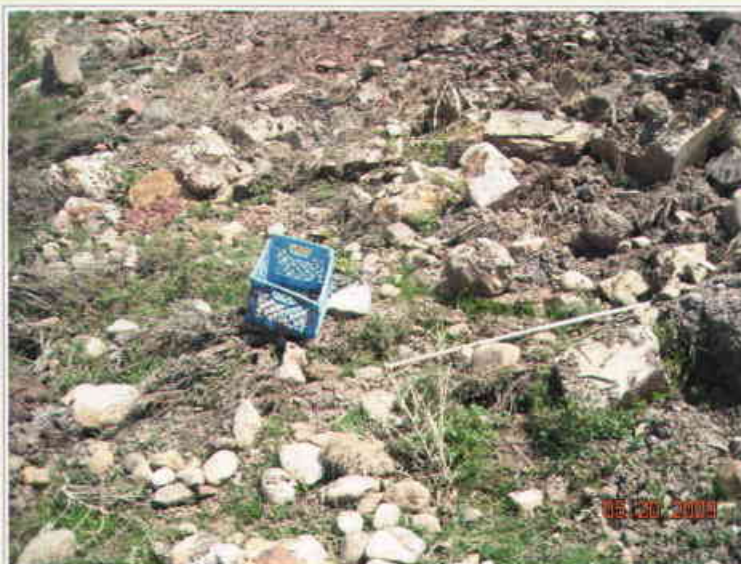
Garbage.

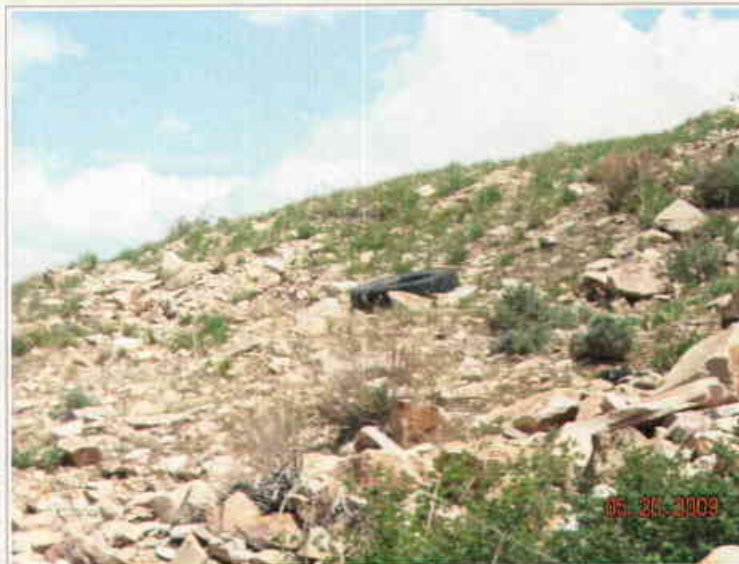
Garbage.

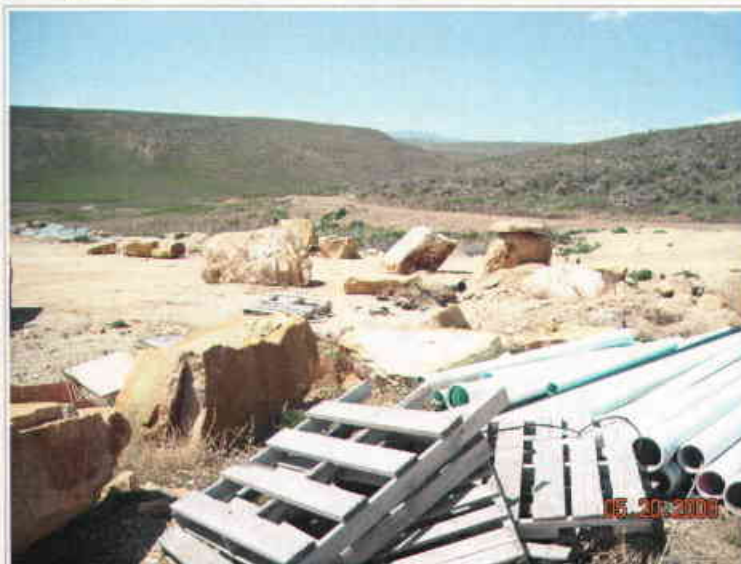
Pallettes and debris in the lower crushing facility to be removed.

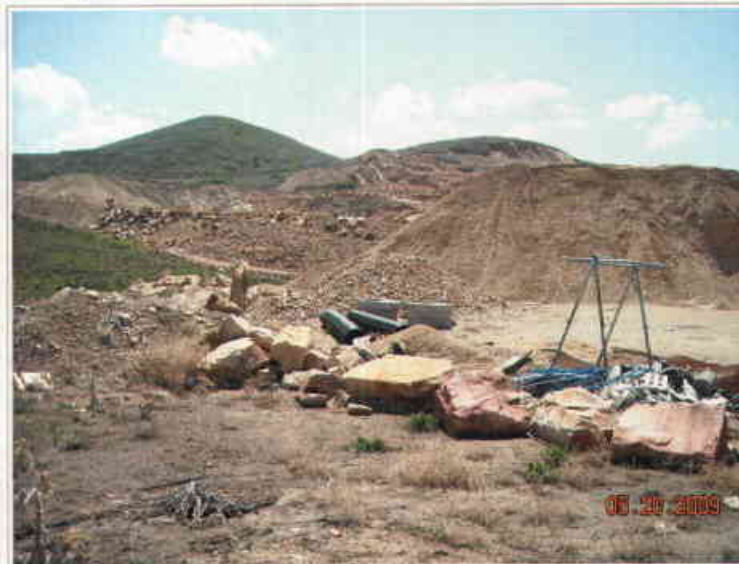
Lower pit with crushed rock and minor stockpiles of soil around the perimeter.
